Inspection Report for

B-20-081

BROOKE ST over E BR FOND DU LAC RIVER

Oct 27,2020

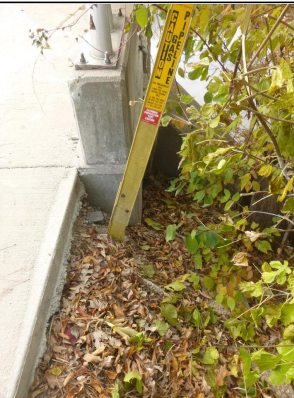
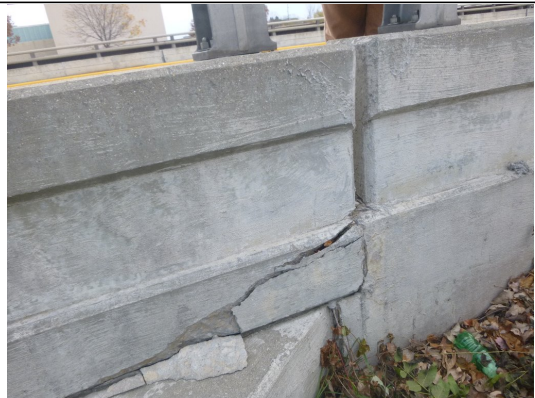
Chk	Element	Defect	Description	UOM	Total	Quantity in Condition State			
						1	2	3	4
X	9001		Drainage - Ends of Structure NW and SW quadrant settling where fill and/or riprap is required	EA	4	2	2	0	0
X	9009		Sidewalk Sidewalk delam. repaired 2015 and joints over pier repaired in 2017. West sidewalk overhang has 16 SF of CS3 cracking with heavy efflorescence.	EA	2	1	0	1	0
X	9011		Utilities 12" insulated water and 8" gas hanging on west sidewalk, insulation deteriorating, brick and concrete spalling at connection to NW abutment. Unknown utility east side between bridge and railroad bridge.	EA	3	1	1	1	0
X	9047		Slope Protection- Other Vegetation over some small stone northwest and southwest, adjacent old railroad structure NE and SE, B-20-247 .	EA	2	2	0	0	0
X	9248		Culvert End Treatment 12" RCP located in NW abutment	EA	1	1	0	0	0
X	9323		Approach Roadway - Asphalt Concrete approach milled and paved with asphalt	EA	2	2	0	0	0

Drainage - Repair Washouts / Erosion	LOW	Conto, Thomas J (3531)	IDENTIFIED	11/19/20
Repair washout or settled area along back of walk and along wing wall. Install fill or riprap in NW and SE corners

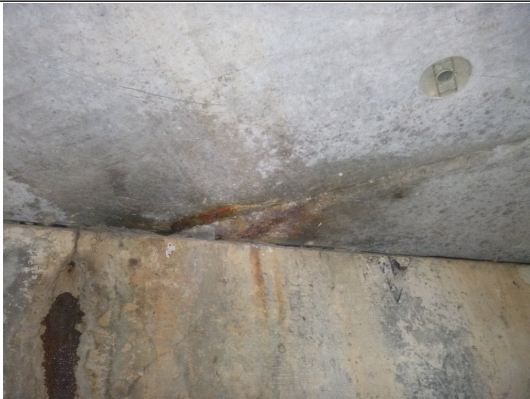
Routine Item 8

Cracking (PSC)	LF		0	0	15	0
			Cracking at Pier and Abutments w/Rust staining (CS3):						
		1110	Girders (G#) numbered from east to west per each span: North span at Pier (Crack): G1, G6, G7, G14 and G15 (1' EA, or Total = 5' CS3) South span at Pier (Crack): G5, G6, G7, G9, G13, G16 and G17 (1' EA, or Total = 7' CS3) At Abutment: North at Abutment (Crack): G6 (1' EA, or Total = 1' CS3) South at Abutment (Crack): G8 and G13 (1' EA, or Total = 2' CS3)						
X	210		Reinforced Concrete Pier Wall	LF	255	235	11	9	0
			Delamination - Spall - Patched Area	LF		0	0	3	0
		1080	Spall 3'x1'x2" deep spall at top of wall under 5th Girder from west						
			Cracking (RC)	LF		0	11	6	0
		1130	Several vertical hairline cracks, <.05" - 5' horizontal and 6' vertical narrow cracks (CS2) - 4' narrow cracks with efflorescence and rust staining (CS3) 2' wide crack with rust staining at west nose of pier (CS3)						
X	215		Reinforced Concrete Abutment	LF	336	309	13	14	0

Action Plan: Structural Review	Created: 19-Nov-2020	Due: 28-Dec-2020
Overall Notes: Box girder defects along the pier and the abutments are progressing from seepage of road chlorides through deck seals. The pier compression joint seals were replaced (BEJS EMseal) in 2017 along with a new overlay and the approaches were hot tar sealed in 2019. However, the defects are evident and noted on this inspection report.		
Reviewer: Pence, Alex	Reviewer PE Number: 40925-6	Review Method: engineering judgement

Cracking, spalling and exposed prestressing and stirrups at end of box girder at abutments (Typ.) (CS4)

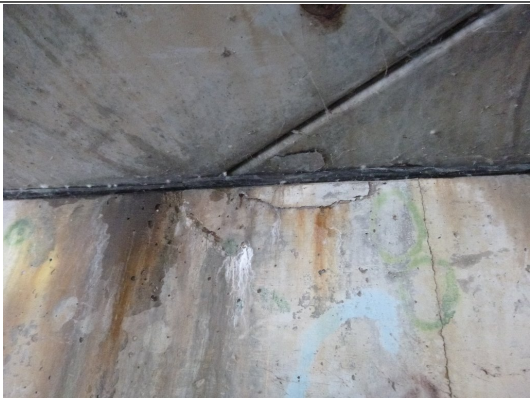
Routine Item 9

Cracking and delamination at end of box girder (CS3) at pier and pier cracking (CS2)

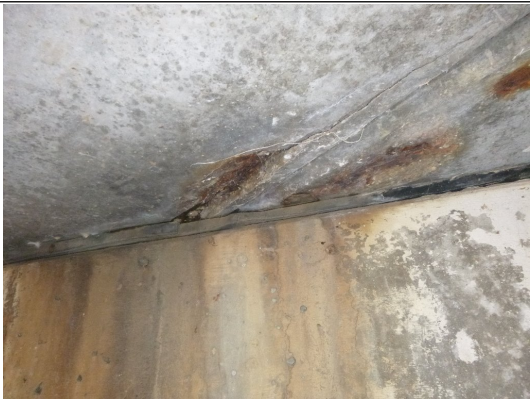
Routine Item 10

Spalling, exposed, corroded and broken stands/stirrups (C4)

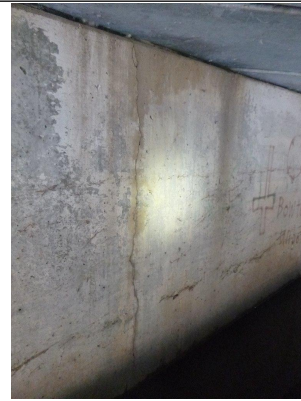
Routine Item 11

Cracking and staining of pier wall (CS3)

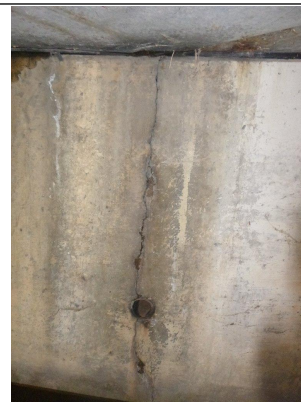
Routine Item 12

Delamination - Spall - Patched Area	LF		0	0	5	0
		1080	Spalling at NW corner with exposed rebar 5'x2.5'x3" above watermain utility.						
			Cracking (RC)	LF		0	13	9	0
		1130	North Abutment: 5 CS2 and 3 CS3 cracks South Abutment: 8 CS2 and 6 CS3 cracks

Cracking and staining of abutment (CS3)

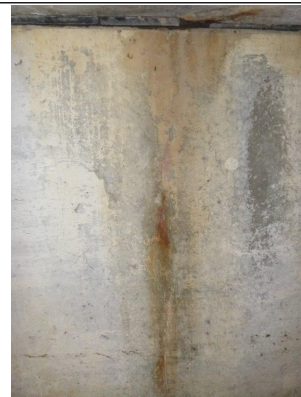
Routine Item 13

Abutment cracking, staining and water leaking from approach (Typ.) CS2

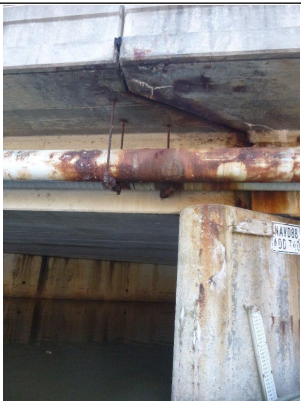
Routine Item 14

Cracking of topside of pier (west end) (CS3) and staining end of box girders as pier. Corroded abandoned watermain, water level indicator at center pier (west) damaged

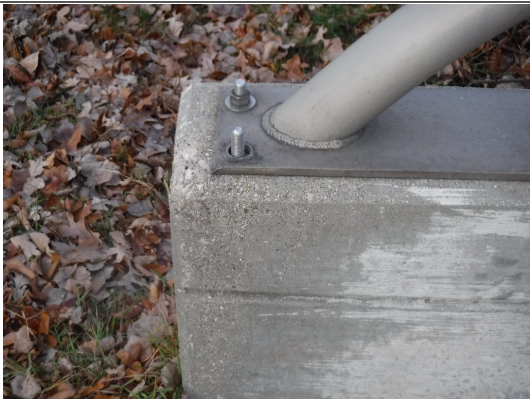
Routine Item 15

X	9335		Decorative Rail Corroded nuts on east rail midspan. Missing nut on approach rail corner.	EA	2	0	2	0	0

Missing railing nut SW corner

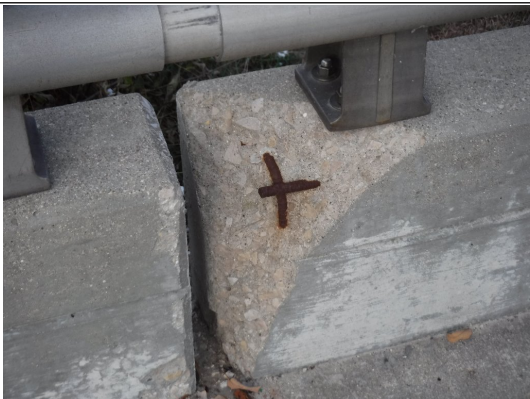
Routine Item 16

Spall and exposed rebar end of parapet at center pier expansion joint (CS3)

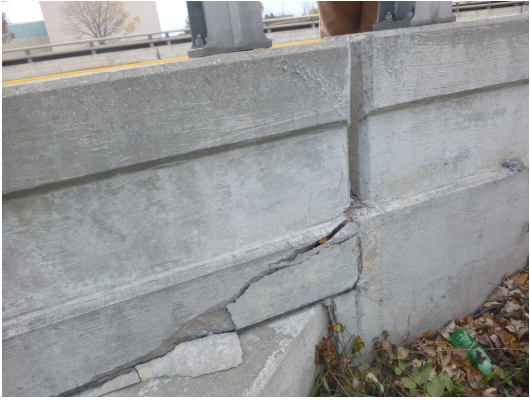
Routine Item 17

Spalling of back side of bridge railing SW end of deck (CS3)

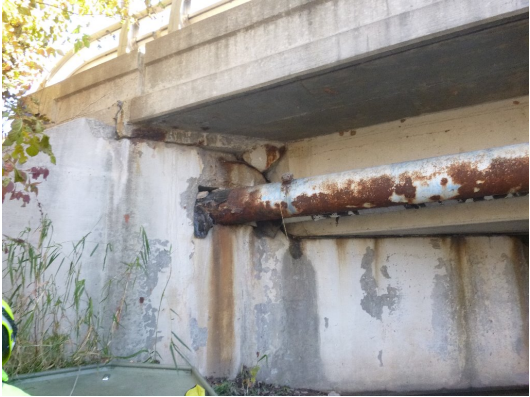
Routine Item 18

Abandoned water main and spalling of abutment above, NW quadrant. Exposed rebar with section loss (CS3)

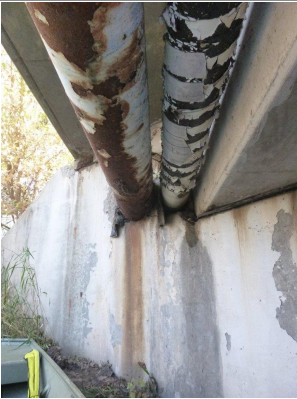
Routine Item 19

Abandoned water main and existing gas main utility, NW quadrant.

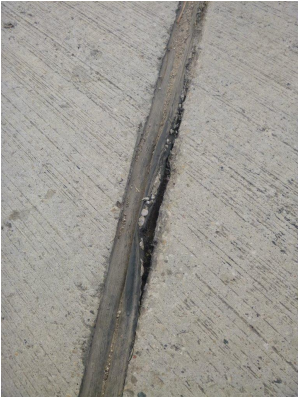
Routine Item 20

X	302		Compression Joint Seal	LF	96	66	0	30	0
			Mid span joint replaced in 2017 (BEJS System- Joint Sealer). End joints replaced d through walk as well.						
		2310	Leakage, Seal Adhesion, Damage, Cracking	LF		0	0	10	0
			Comp Seal about 10' CS3 seal adhesive failing						
		2350	Debris Impaction	LF		0	0	20	0
			Comp Seal about 20' CS3 debris impacting the seal						
X	331		Reinforced Concrete Bridge Rail	LF	269	246	17	6	0
			Several HL cracks in parapet; East railing includes 1.6 foot wide adjacent curb/median.						
		1080	Delamination - Spall - Patched Area	LF		0	0	4	0
			Delamination and spall at corners: - SW 12"x20"x5" w/ exposed rebar - SE 12"x2"x2" (approach railing) - SW 30"x10"x1" back side of rail, overlapping other spall (above) - SE 6" diameter spall at curbline						
		1130	Cracking (RC)	LF		0	17	2	0
			Cracking Narrow (CS2) and medium with rust staining (CS3): - East Rail: 11' CS2 Map cracking and 2 CS3 w/rust staining - West Rail: 6' CS2 Map cracking

Damaged compression seal (CS3) at pier west end
