Inspection Report for

**B-20-053**

**STH 23-JOHNSON ST over DE NEVEU CREEK**

**Oct 27, 2020**

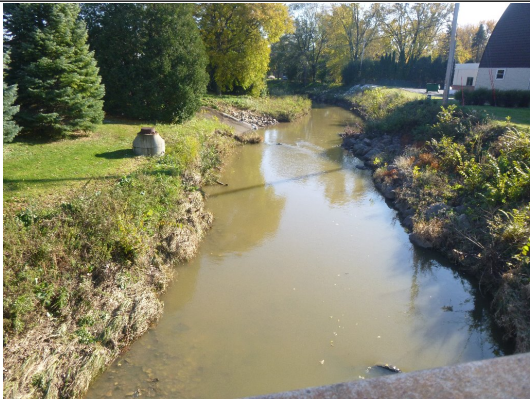
**Routine Item 4**

Upstream, south

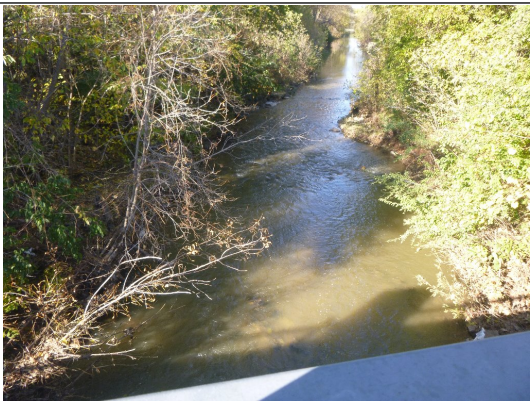
**Routine Item 5**

Downstream, north

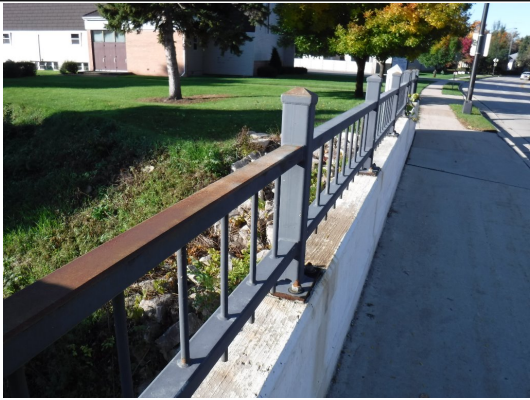
**Routine Item 6**

Railing corrosion (Typ.)

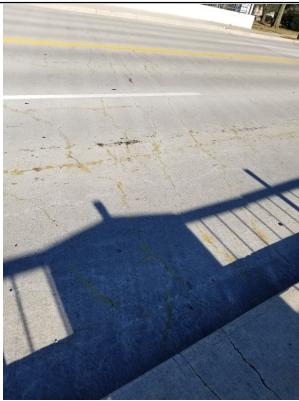
**Routine Item 7**

Deck cracks sealed in 2014 and resealed in 2019 with TK9030 epoxy

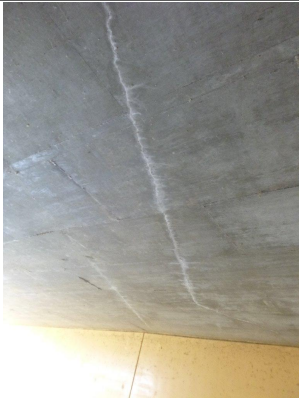
Routine Item 9

Underside deck cracks with efflorescence, CS2 (Typ.)

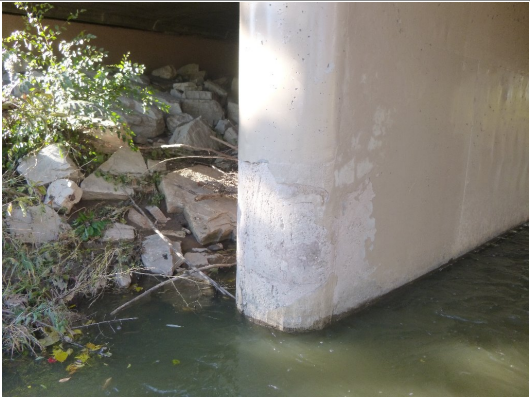
Routine Item 10

Minor abrasion to west pier south and north end, CS2 (Typ.)

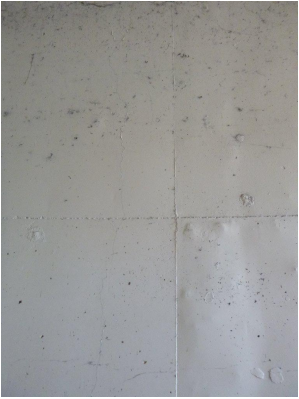
**Routine Item 11**

Pier and abutment cracks, CS2 (Typ.)

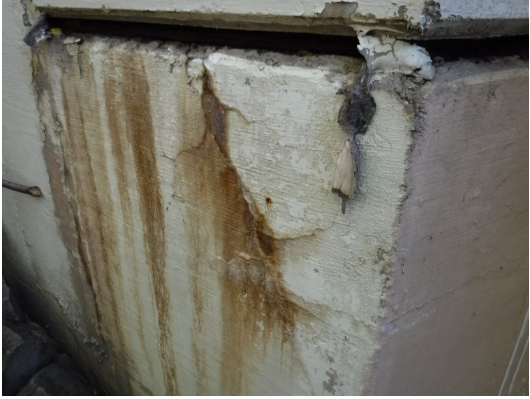
**Routine Item 12**

Cracking (RC)	LF		0	<b>6</b>	<b>1</b>	0
		1130	Random vertical narrow cracking at abutments (CS2) <b>4 LF on east and 2 LF on west.</b> <b>NE corner of east abutment, 1 LF (CS3) cracking with efflorescence and rust staining</b>						
X	331		<b>Reinforced Concrete Bridge Rail</b>	LF	236	<b>186</b>	<b>50</b>	0	0
			Re-caulk joints. Re-stain or epoxy paint railing <b>at the peaks.</b>						
		1130	Cracking (RC) Few vert. HL cracks leaking down onto slab. <b>- 13' on south rail</b> <b>- 5' on north rail</b>	LF		<b>0</b>	<b>18</b>	0	0
X	8400		<b>Integral Wingwall</b>	EA	4	4	0	0	0
		1190	Abrasion-Wear (PSC-RC) Concrete deterioration on top of parapet.	LF		0	<b>32</b>	0	0

Cracking with efflorescence and rust staining of NE corner of abutment, CS3

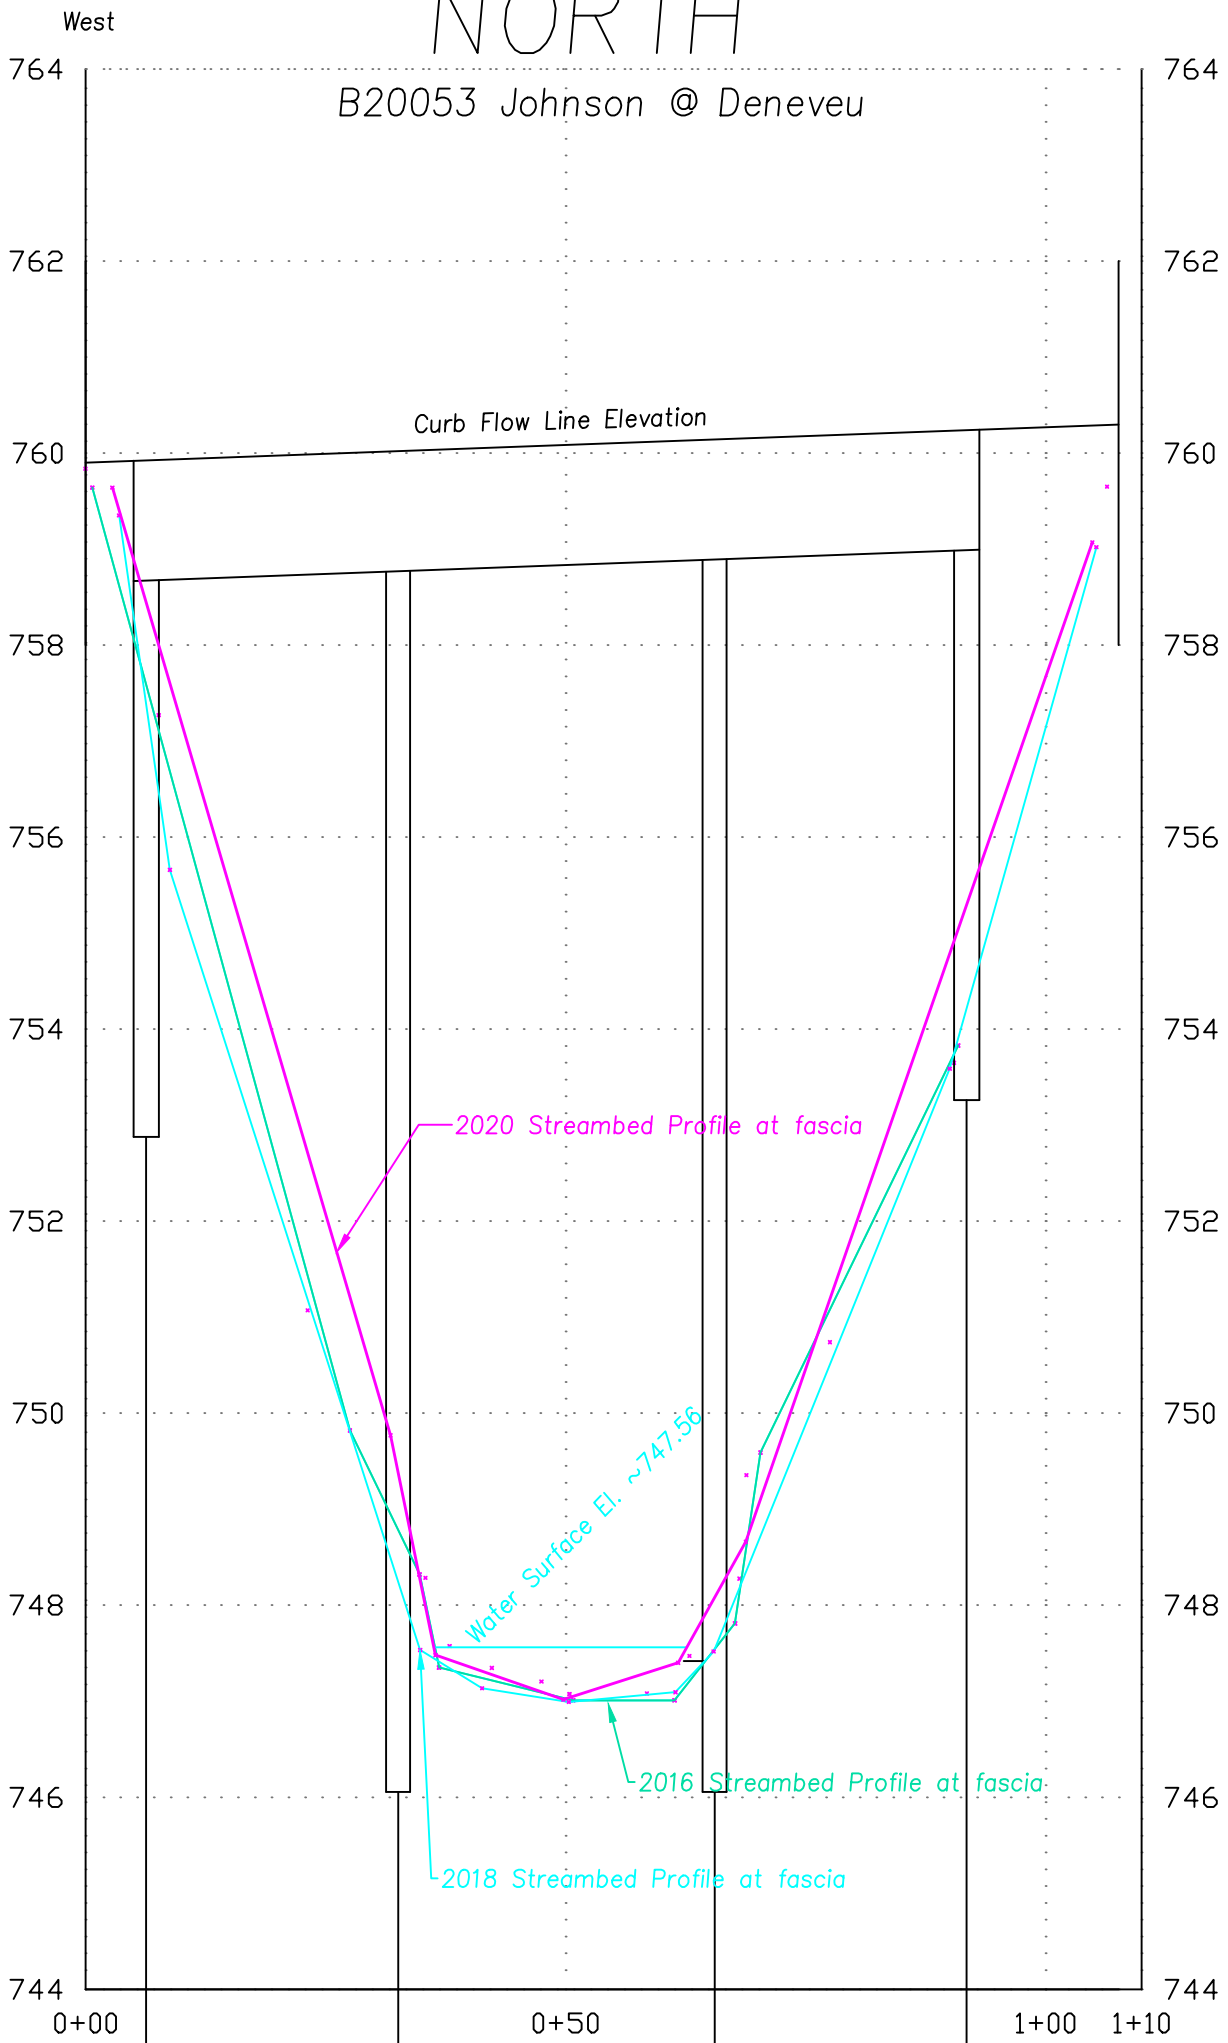
# NORTH

Approximate pile elevation 720
