STATE OF WISCONSIN  
DEPARTMENT OF TRANSPORTATION

Inspection Report for  
B-20-184

MERRIL AVE over DE NEVEU CREEK  
Oct 15, 2018

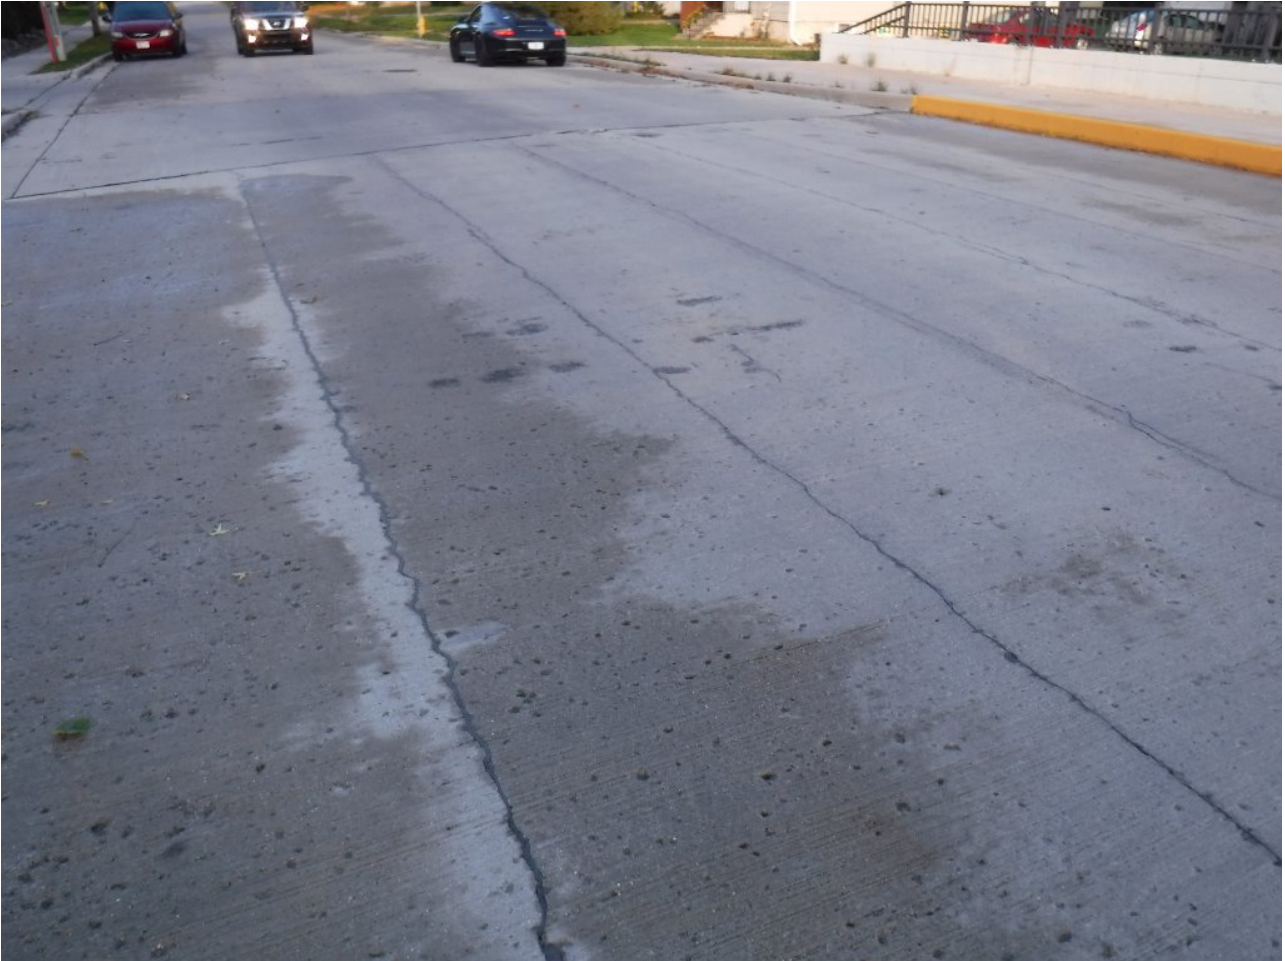
Chk	Element	Defect	Description	UOM	Total	Quantity in Condition State			
						1	2	3	4
X	15		<b>Prestressed Concrete Top Flange</b>	SF	2,840	2,840	0	0	0
			Top of prestressed box beams not visible due to concrete overlay.						
		8514	Concrete Overlay	SF	2,840	1,727	1,109	4	0
			2" minimum concrete overlay. Chert pop outs. Hairline longitudinal cracks between box beams re-epoxied 2014. Compression spall at west approach and bridge center. TK-590 applied to deck, sidewalk and parapet 2014.						
		3210	Debonding/Spall/Patched Area/Pothole	SF		0	709	4	0
			Compression spall at west approach and bridge center. Smaller than 6" spalls developing and chert popouts distributed over entire deck. <b>6" spall 1/2" deep w/standing water at west edge of deck c/l.</b>						
		3220	Crack (Wearing Surface)	SF		0	400	0	0
			Old sealed cracks and new cracks <b>at beam joints</b> , water leaking through to bottom of box beams. <b>Epoxy beginning to fail.</b>

Partially sealed deck cracks between girders

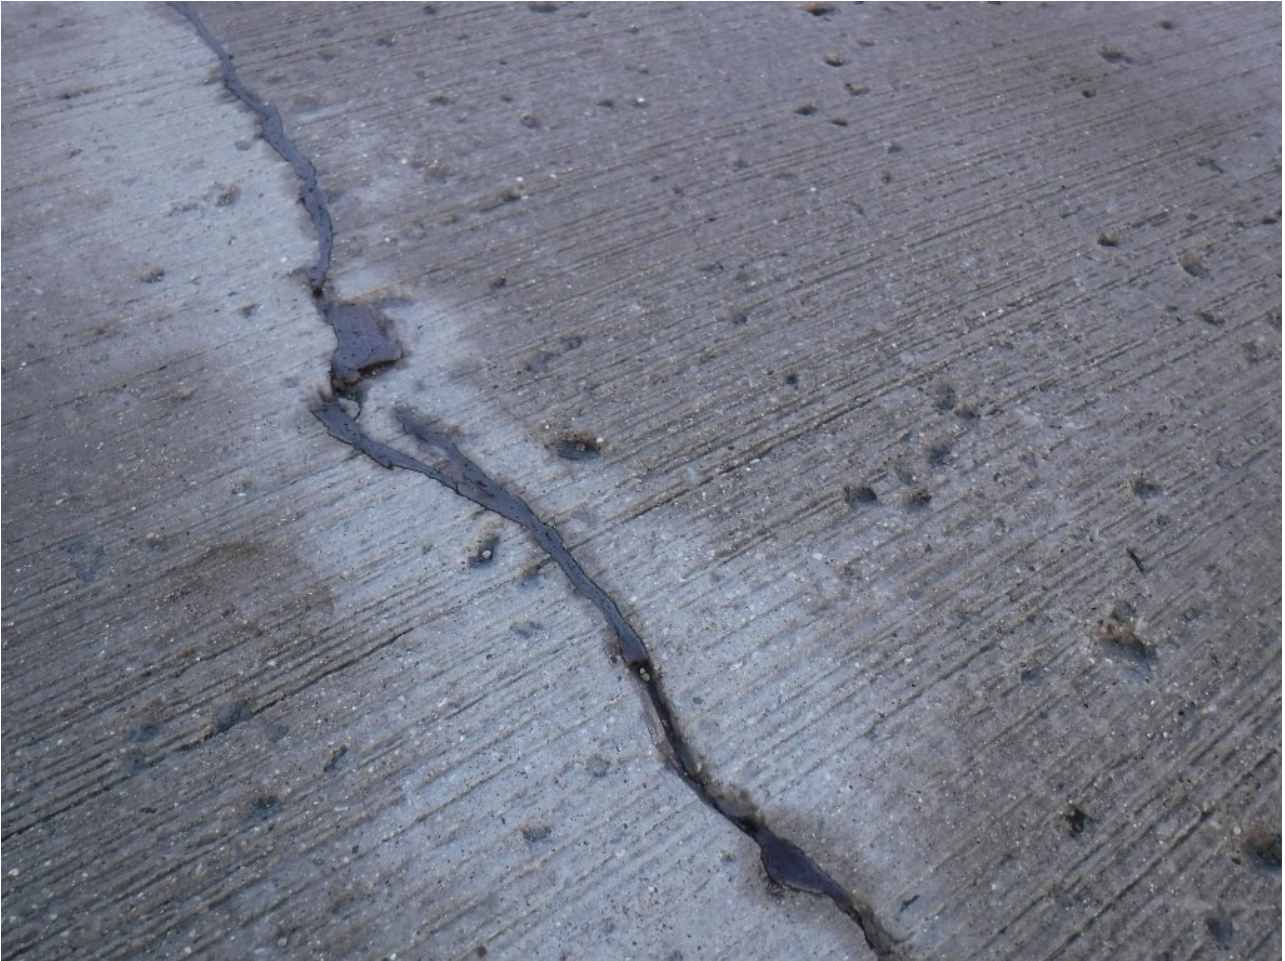
Failing epoxy sealer in deck cracks

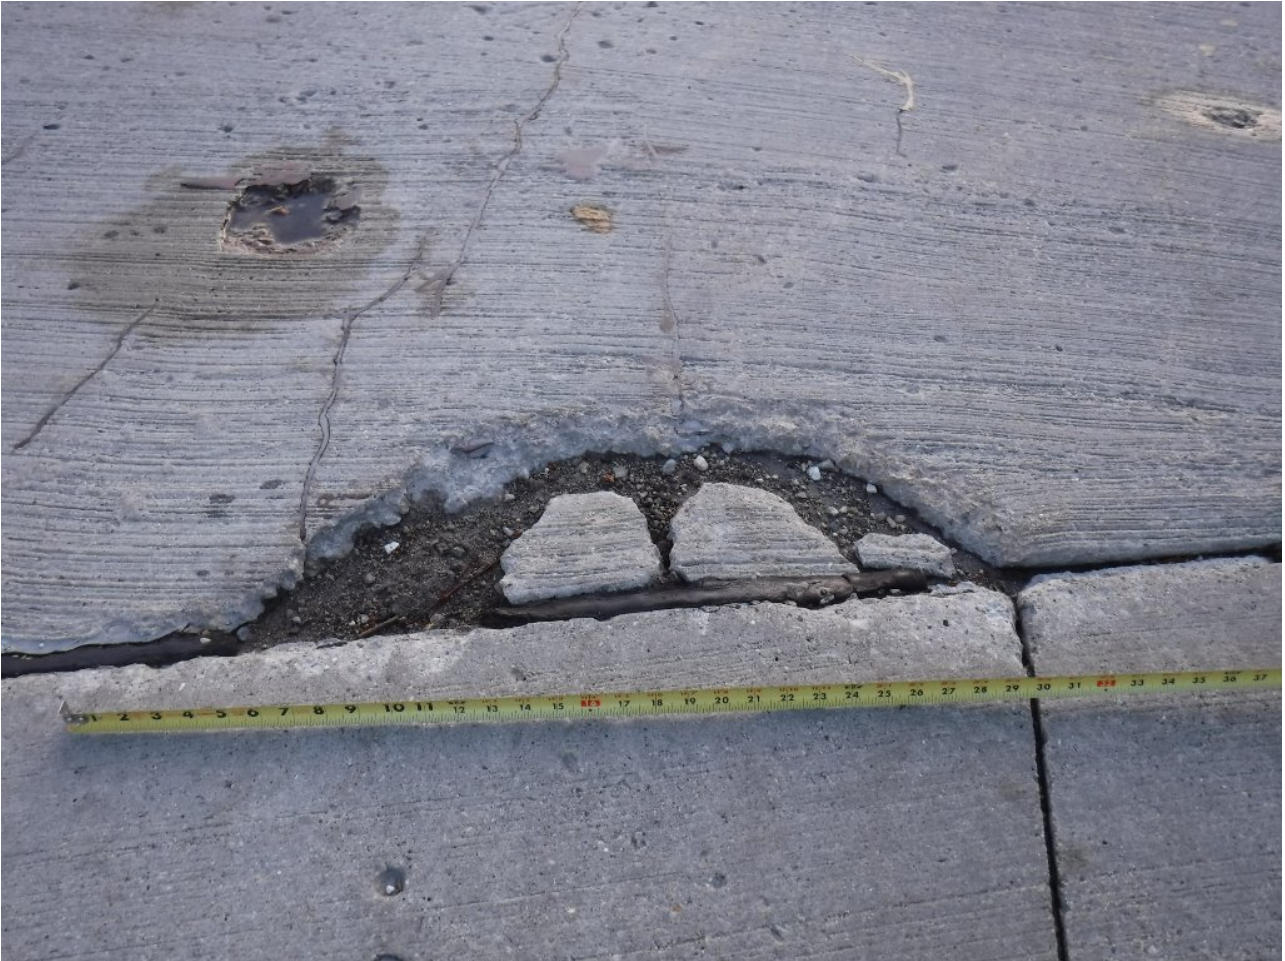
Spall in deck at west near centerline

Item	Priority	Recommended by	Status	Status change
<b>Deck - Patching</b>	MEDIUM	Lang, Anthony (2505)	IDENTIFIED	10/31/14
Patch spall in west center end of concrete overlay				
<b>Deck - Repair Railing</b>	LOW	Lang, Anthony (2505)	IDENTIFIED	10/31/14
Replace missing caps on decorative railing, paint railing. Recaulk joints and decorative railing bolts..

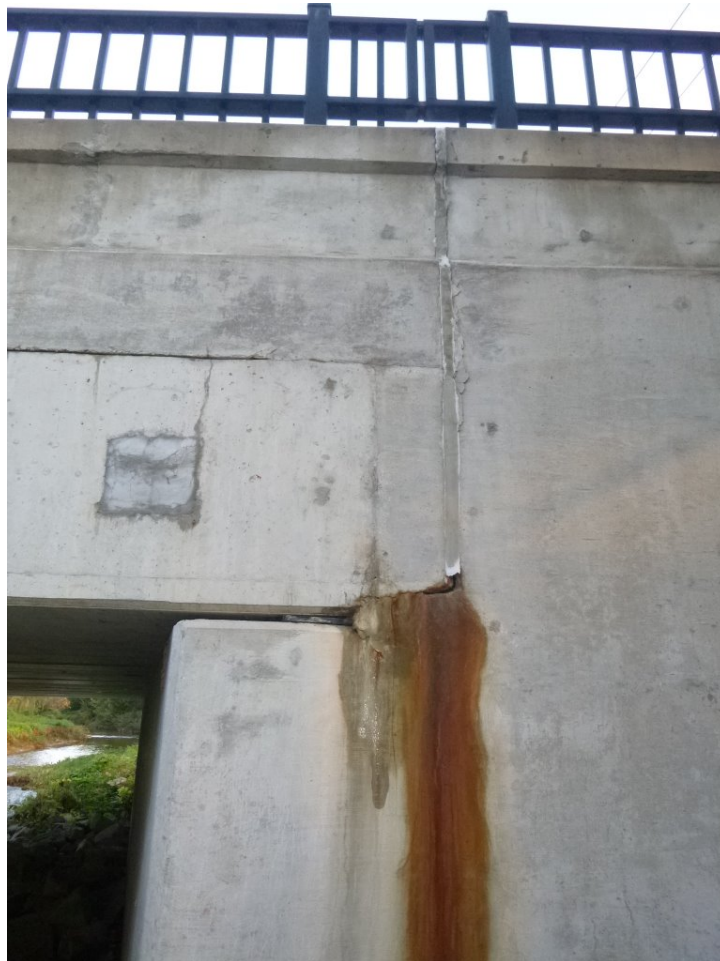
<b>Leak from pavement joint</b> and staining <b>at each</b> abutment joints.

Leaking at back of box beams and abutment below approaches (typ.)

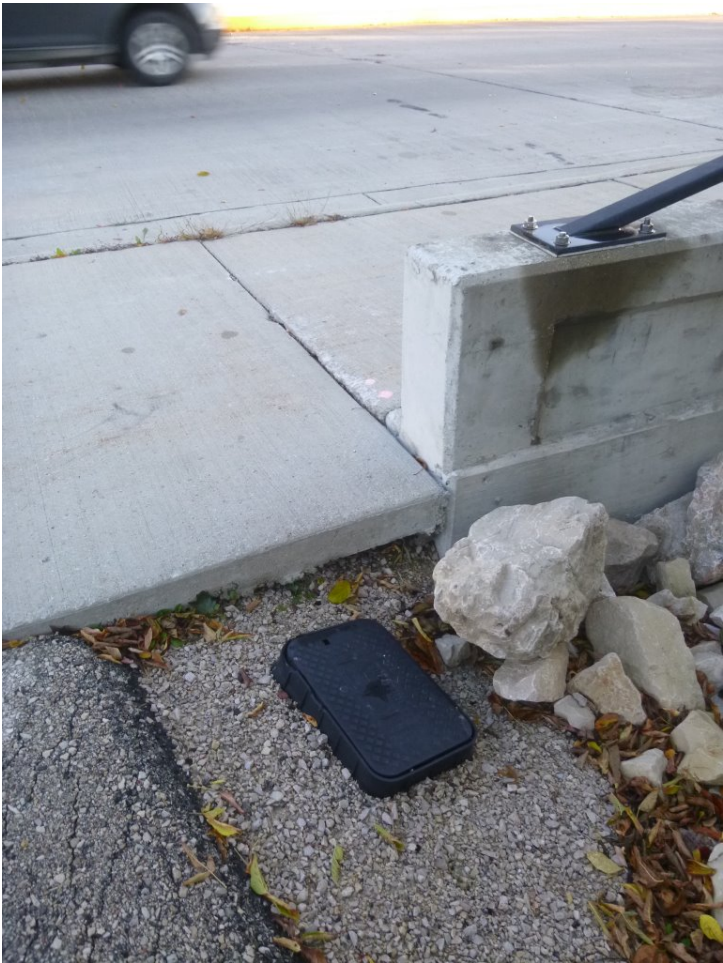
Chk	Element	Defect	Description	UOM	Total	Quantity in Condition State			
						1	2	3	4
X	9001		<b>Drainage - Ends of Structure</b>	EA	4	4	0	0	0
			<b>No issues however some settling in all quadrants except SE, repaired in 2018</b>						
X	9009		<b>Sidewalk</b>	EA	2	2	0	0	0
			Numerous chert pop outs, minor undermined approach <b>NE</b> and <b>SW</b> wingwall. Transverse hairline cracks epoxy repaired 2009 & 2014. TK-590 applied 2014. Sidewalk settled at SW approaches.						
X	9010		<b>Aesthetic Treatments</b>	EA	1	0	0	1	0
			Stain has faded on parapet and paint dull, chipped with rust spots on painted railing which are no longer effective as aesthetic treatment.						
X	9045		<b>Slope Protection- Riprap</b>	EA	2	2	0	0	0

Settling at end of railing (typ.). SE wing filled in 2018

Item	Recommended by	Status	Status change	Year completed
<b>Approach - Other Work</b>	Lang, Anthony (2505)	COMPLETE	11/30/18	2018
Mudjack SW sidewalk slabs approaching bridge, backfill adjacent to sidewalk. SE walk was replaces 2018.

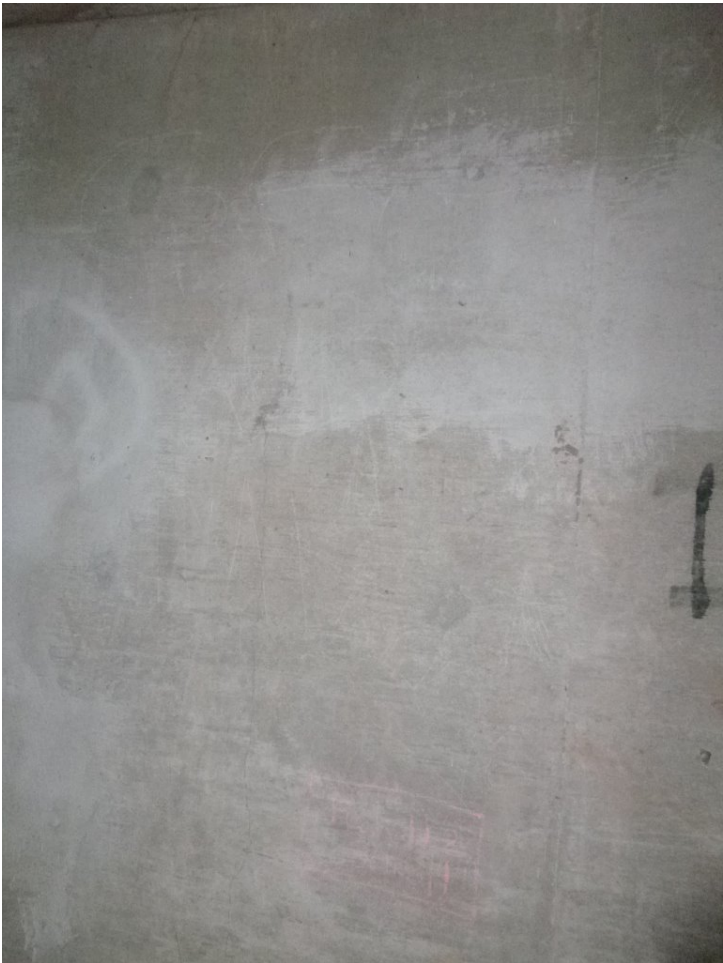
X	104		<b>Prestressed Concrete Closed Web / Box Girder</b>	LF	657	657	0	0	0
			Minor efflorescence or past leakage between beams 4, <b>5</b> , 6, 7, <b>9</b> , 11 and 12 from north.						
X	215		<b>Reinforced Concrete Abutment</b>	LF	122	107	15	0	0
			Caulked parapet joint leaking onto abutment.						
		1080	Delamination - Spall - Patched Area	LF		118	4	0	0
			Caulked parapet joint leaking onto abutment, minor spalling.						
		1130	Cracking (RC)	LF		0	11	0	0
			<b>Random vertical narrow cracking in each abutment. 5 LF in east and 6 LF in west abutment</b>						
X	331		<b>Reinforced Concrete Bridge Rail</b>	LF	181	170	11	0	0
			Caulk failed in joints - re-caulk.						
		1090	Exposed Rebar	LF		0	1	0	0
			<b>Small spall with exposed, uncoated B404 at NW wing inside parapet.</b>						
		1130	Cracking (RC)	LF		0	10	0	0
			<b>Random vert hairline cracks.</b>						
X	8400		<b>Integral Wingwall</b>	EA	4	4	0	0	0

Abutment cracking (typ.)
