STRUCTURE REHABILITATION FEASIBILITY REPORT

**Fountain Island Bowstring Truss Bridge
Lakeside Park
City of Fond du Lac
Fond du Lac County
Wisconsin**

**MSA Professional Services, Inc.
1230 South Boulevard
Baraboo, Wisconsin 53913**

May 2015

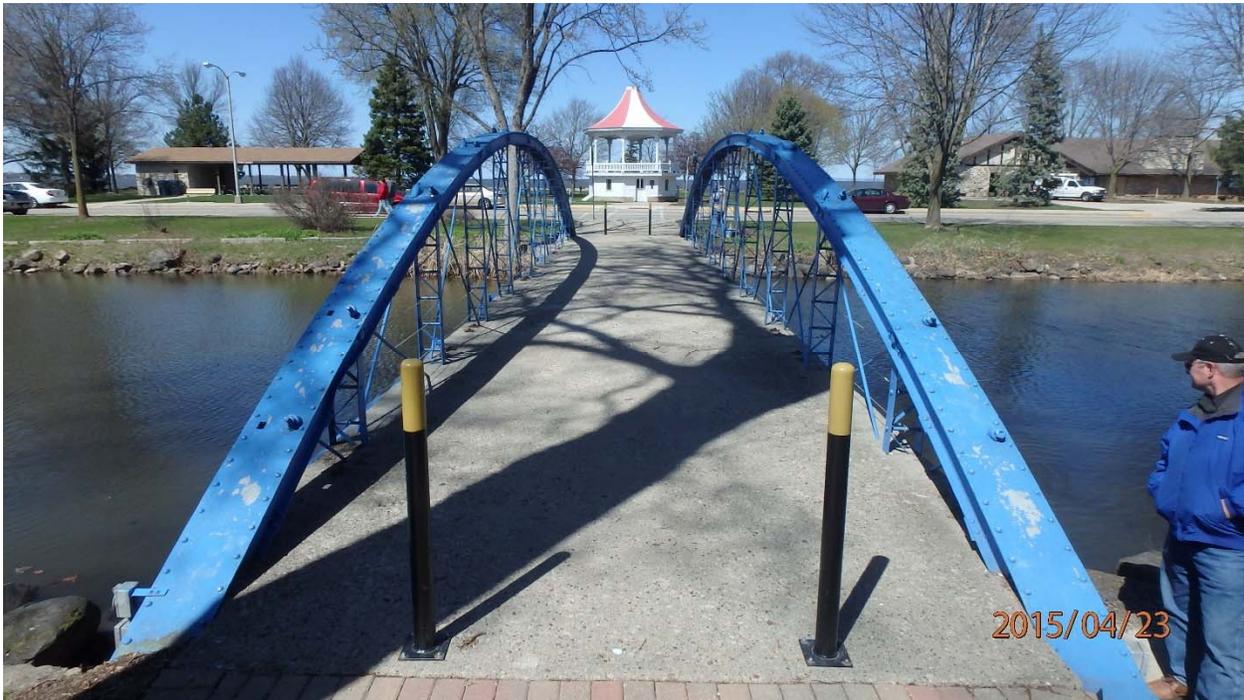
On April 23, 2015, engineers from MSA Professional Services and a bridge contractor met at the structure site with a staff member of the City of Fond du Lac public works department to review current conditions. The 1870's iron bridge, over Lakeside Park channel, crosses from Promen Drive on the north to Fountain Island on the south. The bridge is a 67-foot long single span iron bowstring truss set on concrete abutments. It has a clear width of 10 feet and an out-to-out width of 12 feet. It has a concrete deck. Although it once was a vehicular bridge, it has recently been restricted to just pedestrian use (see Exhibit A, Photo Log, Page 1).

Bowstring Truss Bridge – April 2015
Looking North from Fountain Island Toward Promen Drive

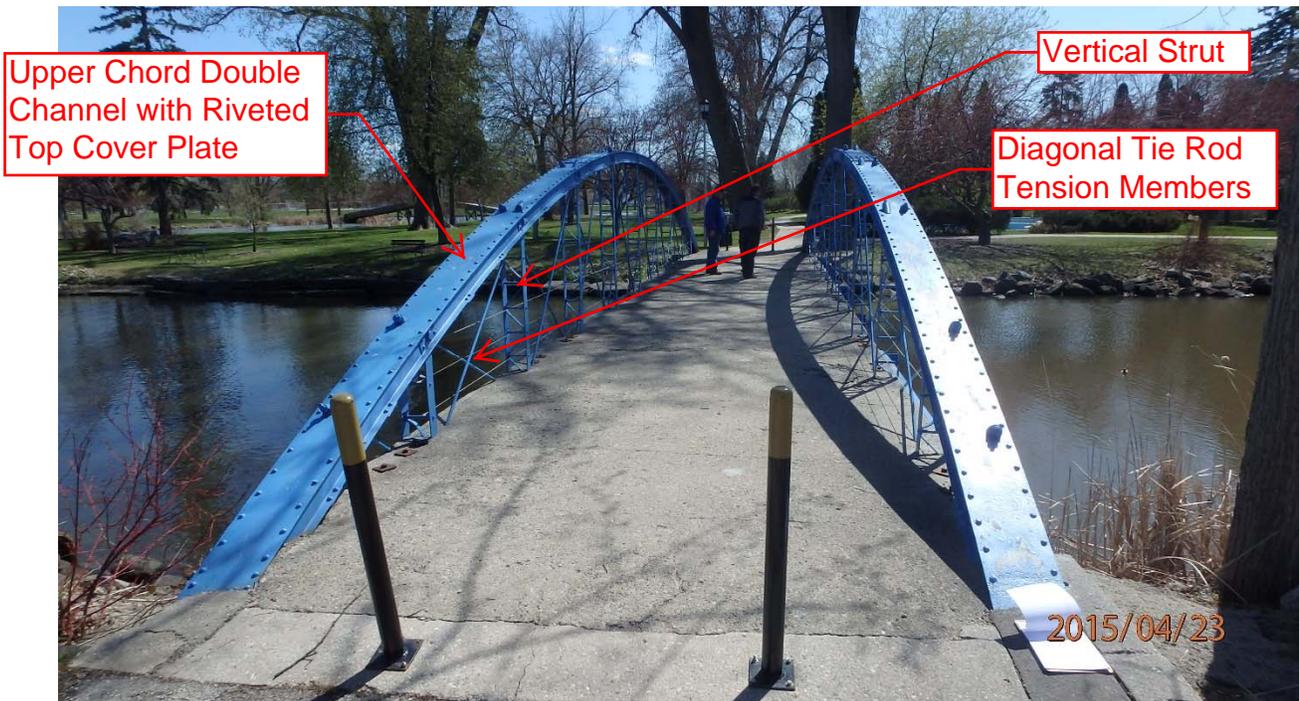
Bowstring Truss Bridge, Looking South – April 2015

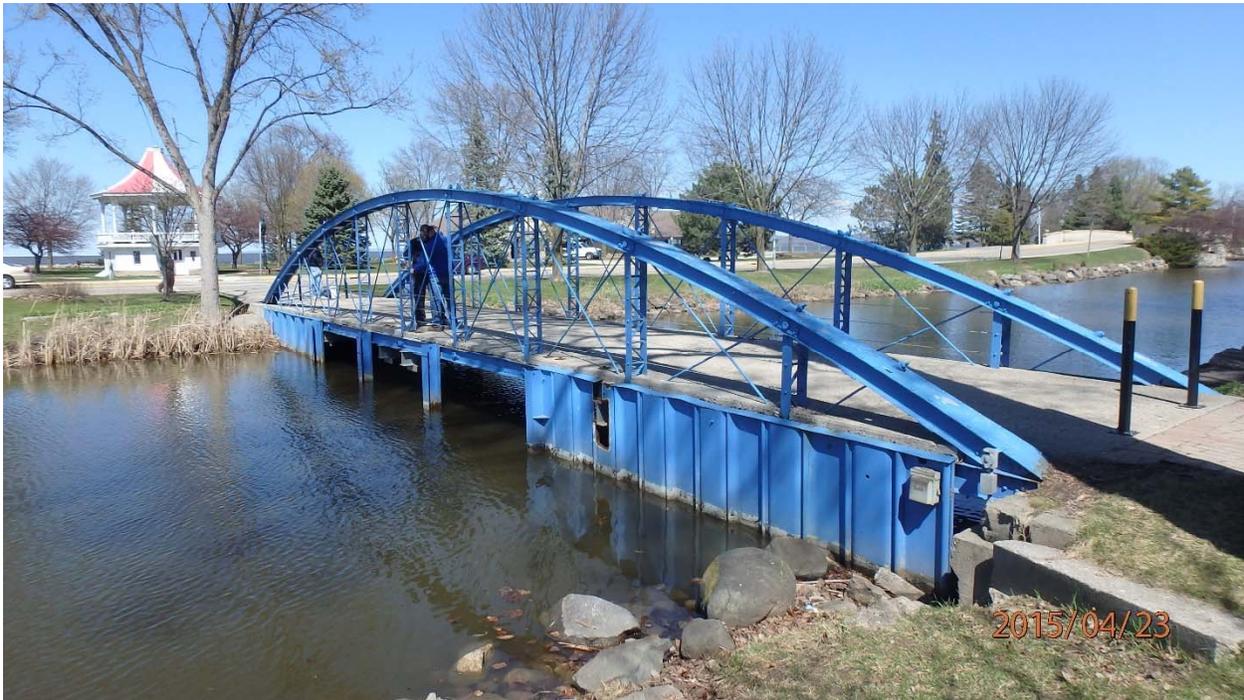
West Side of Bridge – April 2015

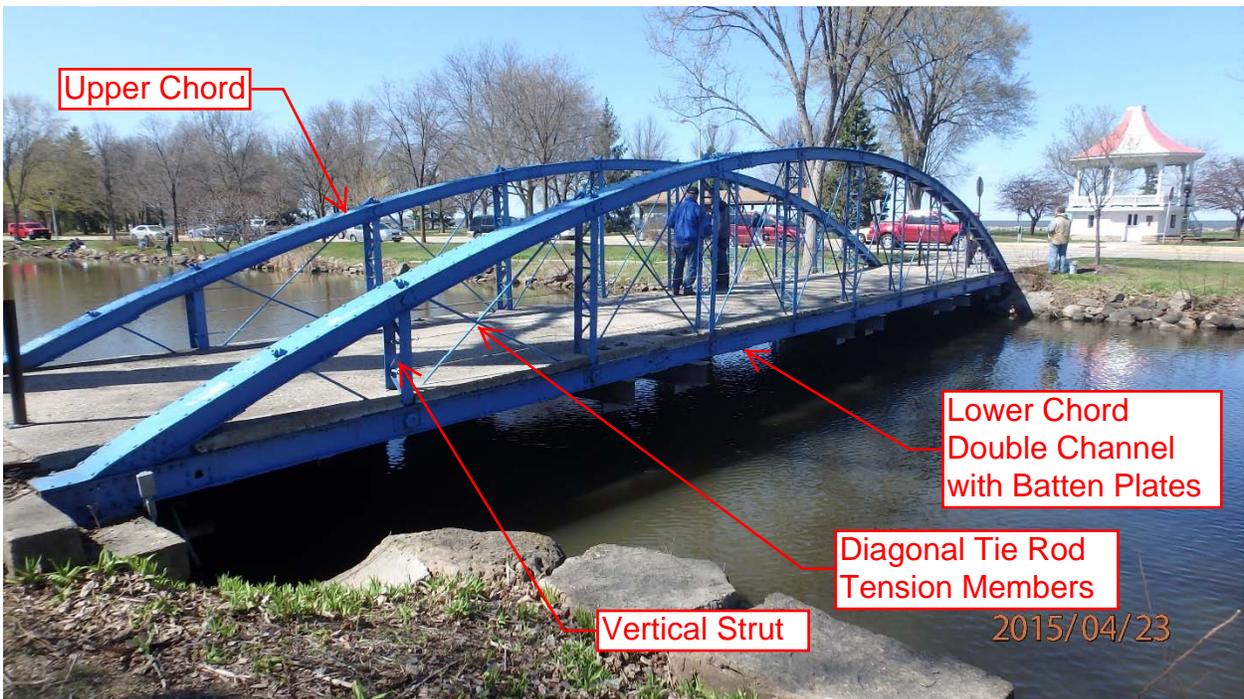
East Side of Bridge – April 2015

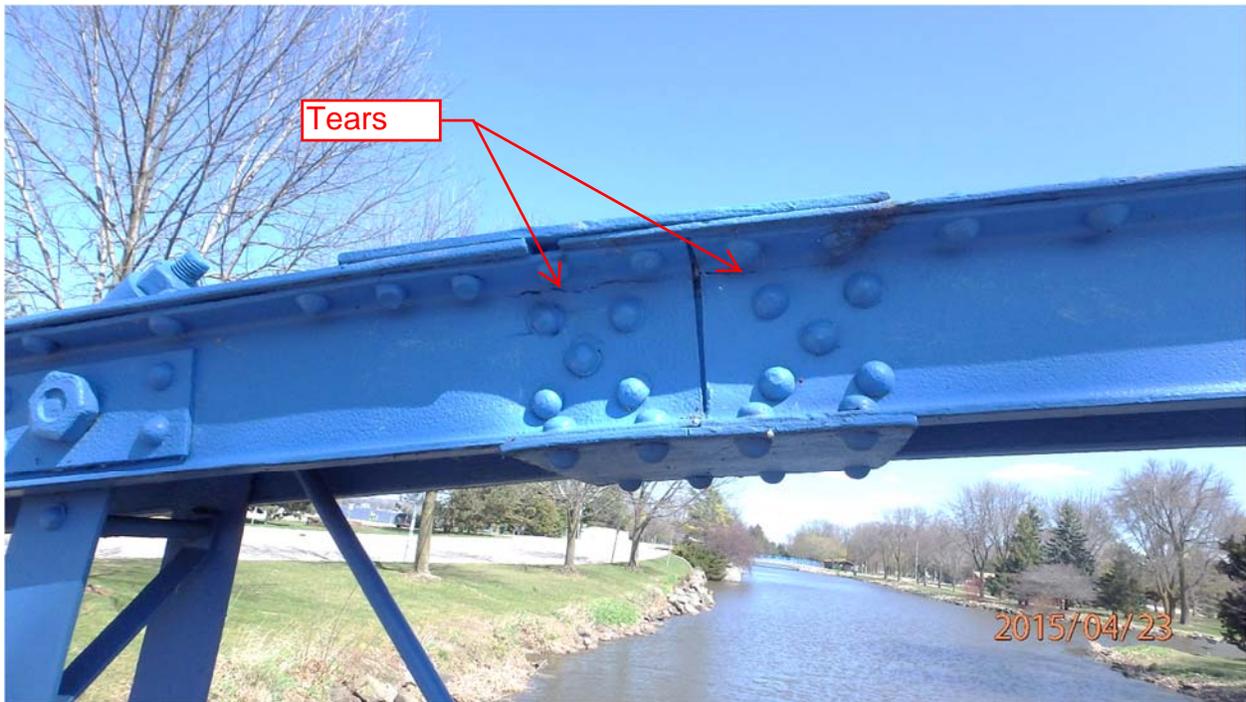
The bowstring truss upper chords, vertical struts, and diagonal tie rod tension members (see Exhibit A, Page 2) are in fair condition above the deck except for the following defects. There are old tears in some of the upper chord channel members around the splices (see Exhibit A, Page 3). These tears have been there for years, perhaps since the 1920's when the truss was moved to the current site. A few of the struts (vertical members) have minor bends probably the result of vehicular damage (see Exhibit A, Page 3). The truss lower chords and under deck steel floor system, consisting of floor beams and stringers, were inspected from a boat. Severe corrosion and section loss were found throughout, including the pin connected lower joints, the floor beams and the stringers. The lower chord members consist of two channel shaped elements. The inner channel shape is corroded the worse. Corrosion in the lower pinned joints impacts also the diagonal tie rod eye bar tension members, with moderate losses of strength, and more critically the vertical strut end plates. Most of these plates below the concrete deck are nearly gone. If the concrete deck were removed, some of these strut compression members would be expected to fail. The diagonal tie rods utilize wedge shaped bushings, or skewbacks, to connect to the

Tears in Upper Chord Splice – April 2015

STRENGTHENING UPPER CORD SPLICES

* ESTIMATE 75 LBS OF STEEL PER SPLICE FOR STRENGTHENING

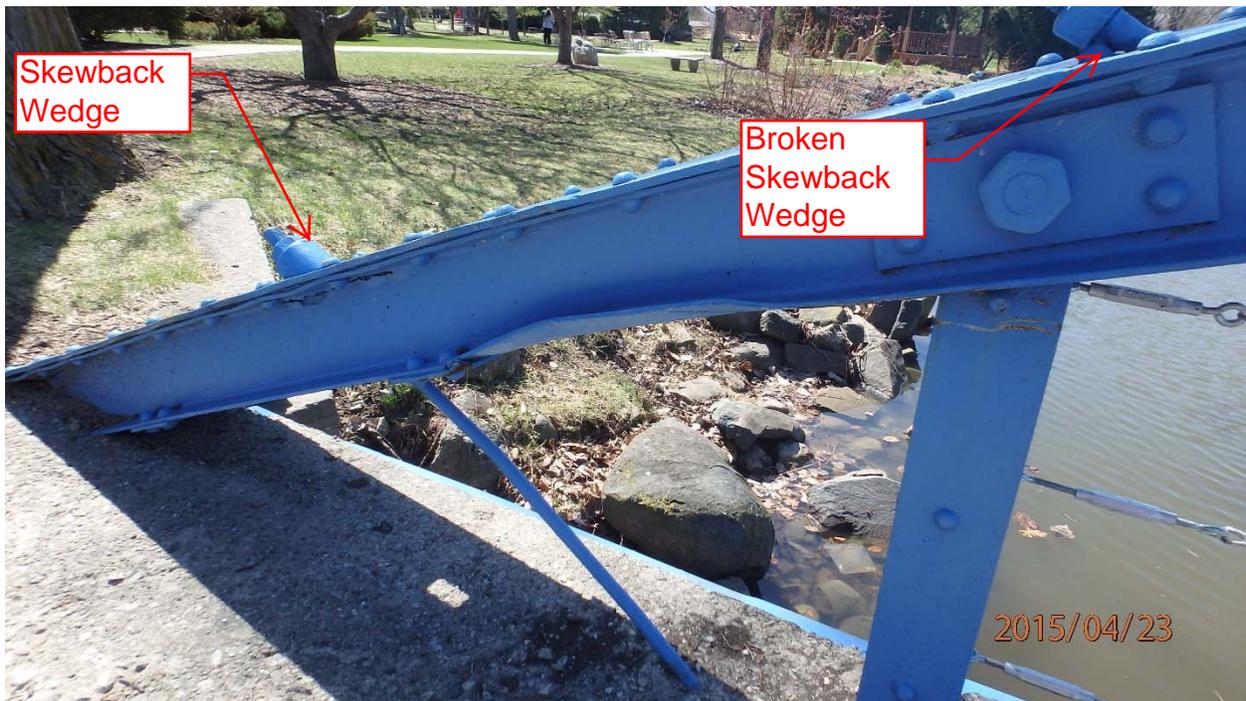
top of the upper chord. Many skewbacks are cracked or broken and need replacement (see Exhibit A, Page 3).

Damage to Upper Chord Near Southwest Corner – April 2015

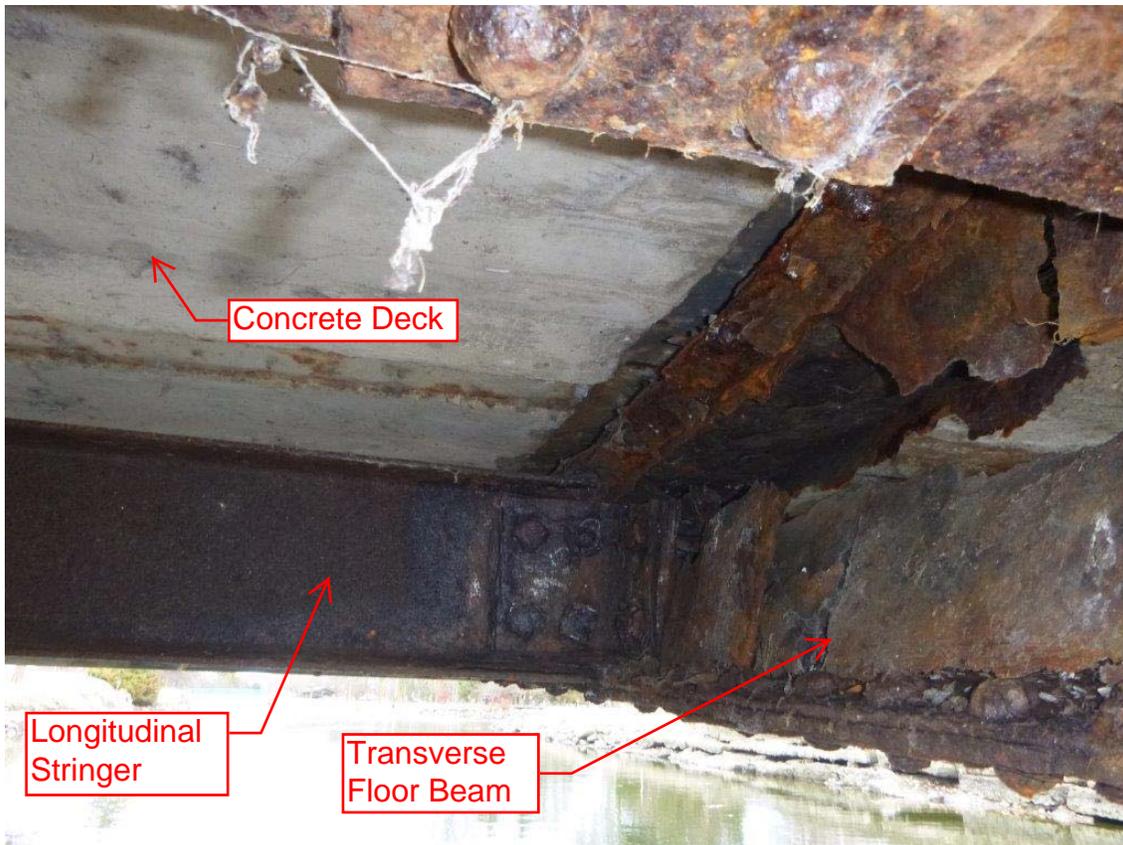
The concrete deck has top surface pitting, but the deck is sound. It has transverse cracks running the full width of the deck. These cracks are located at the quarter points of the bridge length. The concrete deck has reinforcing bars running longitudinal and transverse. On the underside of the deck there are numerous spall locations with exposed reinforcement bars (see Exhibit A, Page 4). There is moderate section loss to the reinforcing bars at these locations.

Underside of Deck Prior to Repairs – April 2014

Corrosion of all structural steel or iron below the existing concrete deck (lower chords, floor beams, and stringers (see Exhibit A, Page 4)) is so far advanced that this material needs to be replaced. All members below the concrete deck should be replaced with new steel designed to meet current code for pedestrian load capacity. Weathering steel is recommended as unpainted it can still provide a long service life in areas not heavily salted. Exact in kind replication of the plate riveted double channel structural shapes used for the existing transverse floor beams is not economically prudent. Fabrication would be much more costly, with little benefit, as few would see them but from underneath. Their function can be more economically served using wide flange (WF) steel beams. The longitudinal stringers would all be replaced in kind with steel beams and framed to the new floor beams.

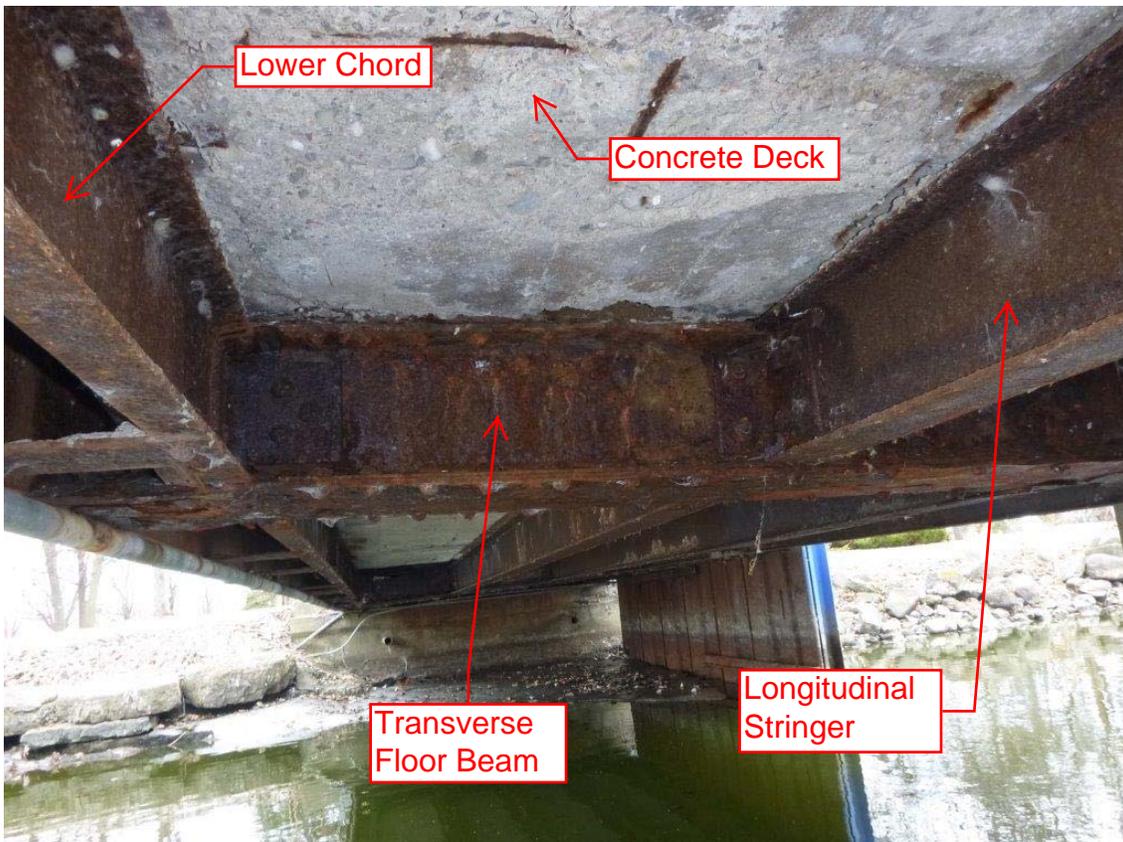
Underside of Deck Prior to Repairs – April 2014

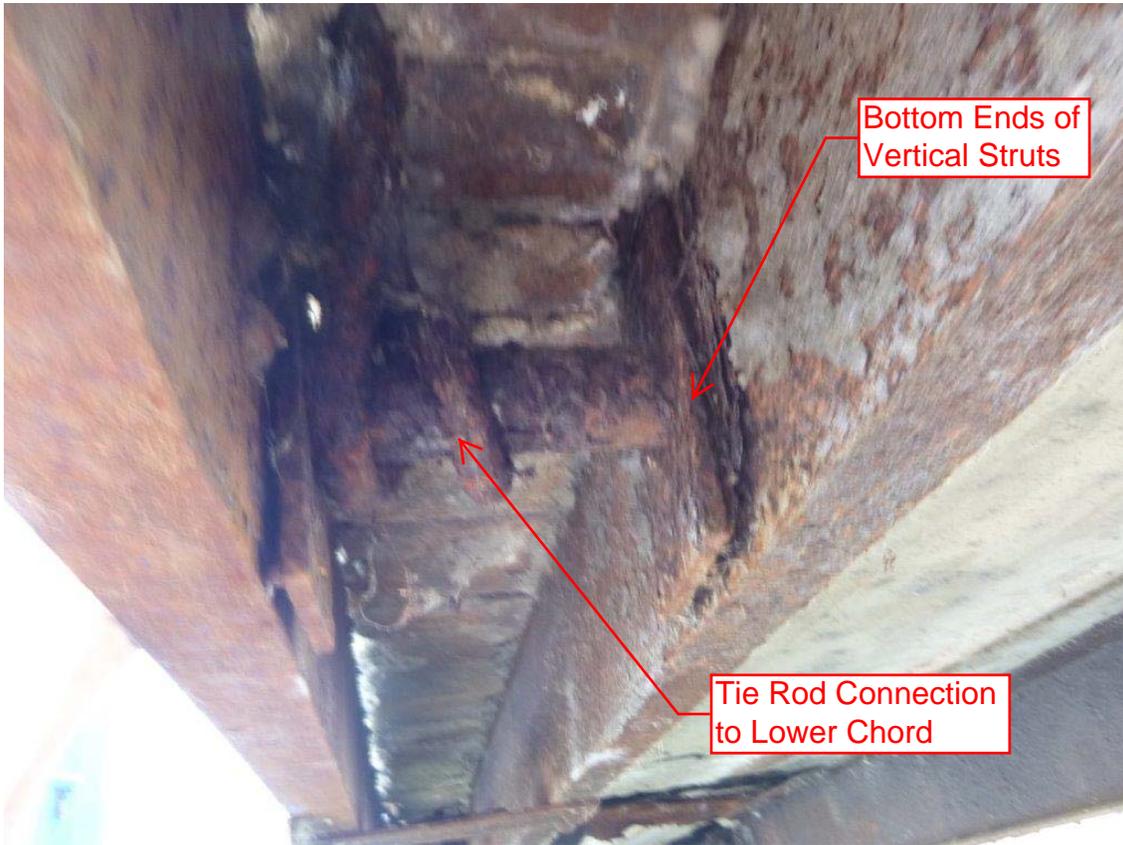
Lower Chord Pin Connection – April 2014

As part of the rehabilitation process it would be most expedient for a contractor to temporarily transport the two side trusses to a shop. This would first require removal of the concrete deck and at least partial disassembly at the site. In each truss the upper chords and diagonal tie rod tension members would be secured for reuse. During further disassembly in the shop, it may be determined necessary to replace some of the diagonal tie rods. The tie rod skewbacks need to be replaced. The upper chord splices, where there are tears in the iron channels (see Exhibit A, Page 3), need to be strengthened using longer internal gusset plates and rivet (huck lock bolt) type connections. The existing vertical strut (compression members) would be preserved except for the corroded ends below the deck at the lower chord pin connections. The lower ends of the vertical struts would be refitted for connection to the pinned lower chord members. The lower chord members also need to be replaced as well as the pins.

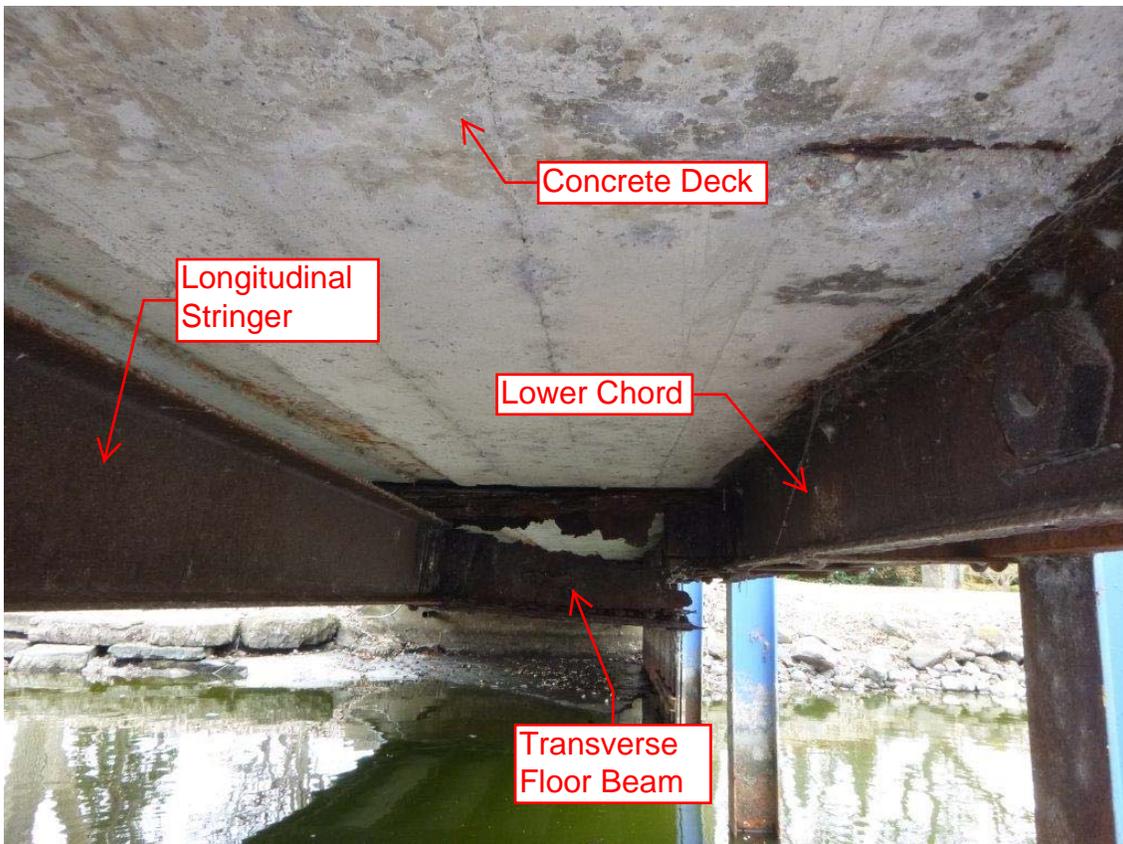
Underside of Deck Prior to Repairs – April 2014

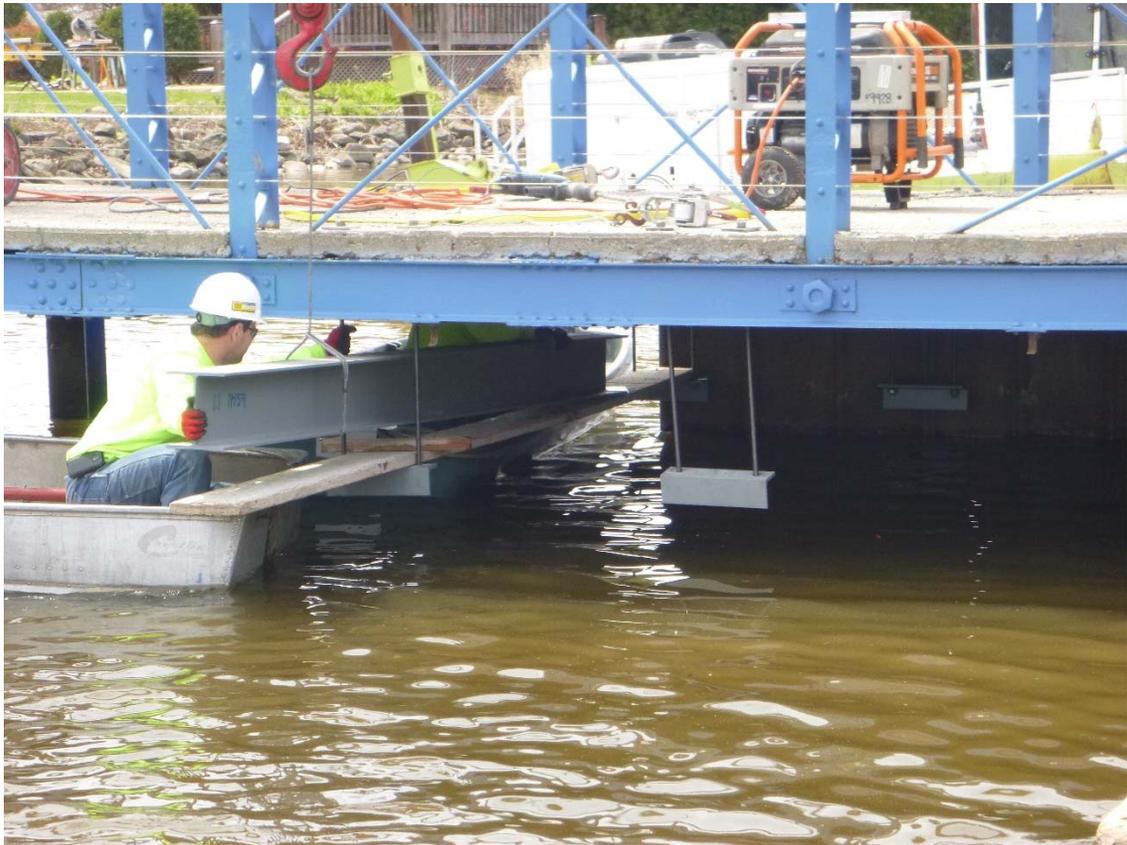
A previous inspection was conducted by MSA in April 2014. MSA provided a repair scheme in which the floor system was temporarily strengthened by installing secondary floor beams beneath the lower chord (see Exhibit A, Page 6). As the original iron floor beams had failed and sagged (see Exhibit A, Pages 4 & 5), that repair restored support to the stringer and the concrete deck. The installation eliminated the sag in the floor beams and the settlement of the stringers from the concrete deck, both of which were observed in the previous inspection. The repair is holding up well, but due to instability around the lower chord connections, resulting from progressive section loss (see Exhibit A, Page 5), the need to either replace or rehabilitate the structure in the near future remains essential.

Installation of Secondary Floor Beams
