Inspection Report for

B-20-010

WESTERN AVE over E BR FOND DU LAC RIVER Aug 26,2021

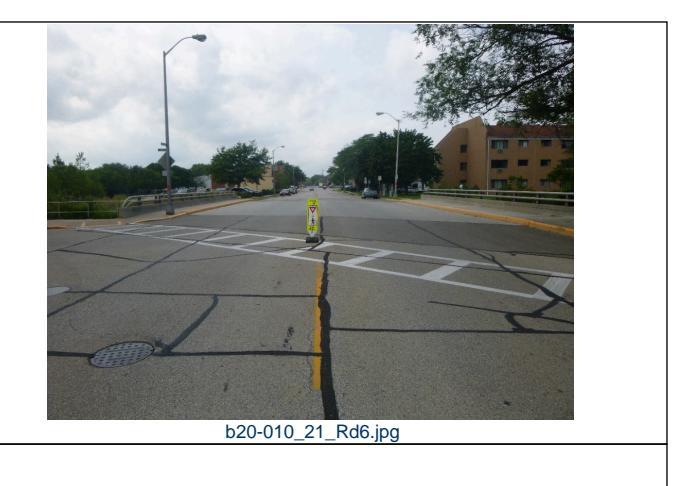
Routine Item 6

East Approach looking west. Recently (2021) sealed approach cracks.

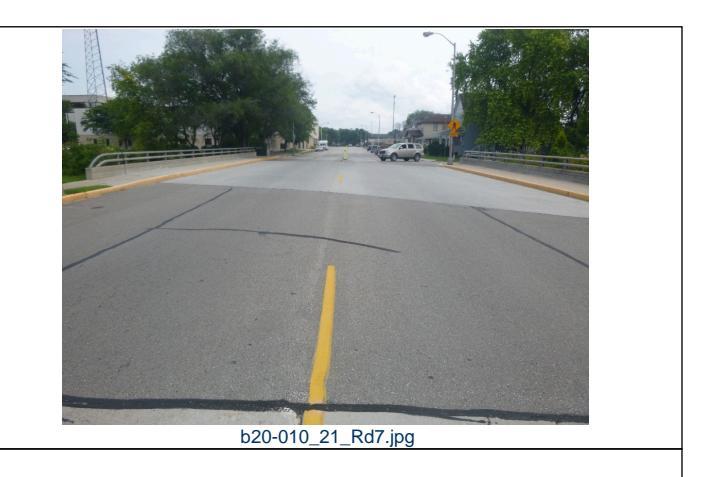
Routine Item 7

West Approach looking east. Recently (2021) sealed approach cracks.

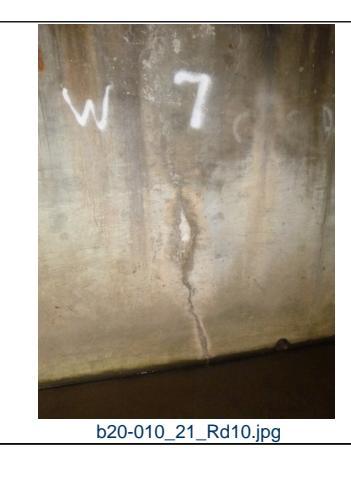
Routine Item 10

Typical CS2 Abutment cracking w/efflorescent (efflor)

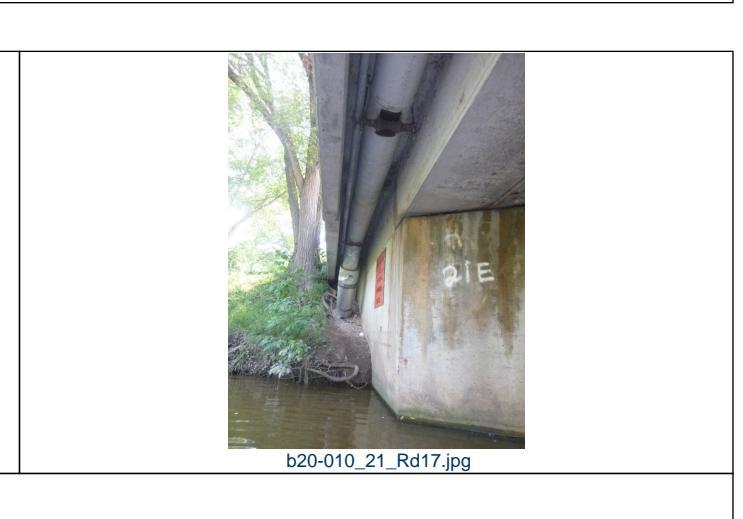
Routine Item 18

Item	Priority	Recommended by	Status	Status change
Misc - Repair / Replace Utilities or Signs	LOW	Conto, Thomas J (3531)	IDENTIFIED	09/14/21
Comment: The watermain insulation could be repaired in the quadrant under sidewalk. Other private utilities co in the NW quadrants as well. Status Comment:	NW and NE uld be repaired	20 21		
Deck - Seal Surface Cracks	LOW	Conto, Thomas J (3531)	IDENTIFIED	09/14/21
Comment: Reseal the centerline joint with an NP1 or other fle sealant and reseal the deck cracks where epoxy s	exible joint ealing is failing.	Status Comment:		
Misc - Other Work	LOW	Conto, Thomas J (3531)	IDENTIFIED	09/15/21
Comment: Various spall on abutment (east), parapet (SE end at integral wing (SE) Status Comment:	d), and parapet

Three utilities under north sidewalk

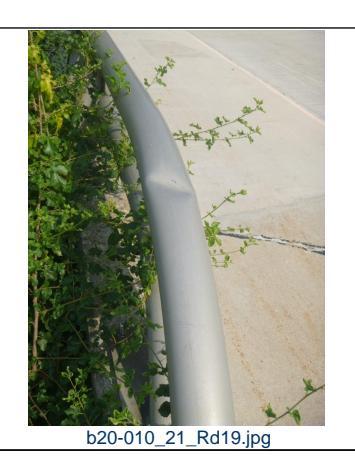
Routine Item 20

Small impact damage to decorative railing NW wing

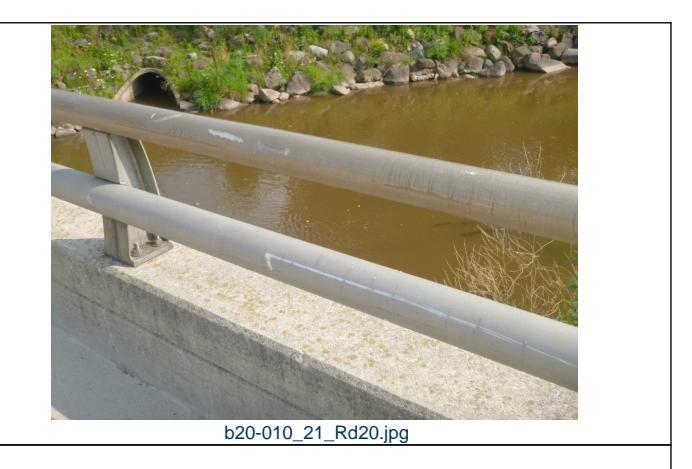
Routine Item 21

Abrasion damage (Typ.). Note, top rail replaced 2018 equipment damage following ice removal spring 2018

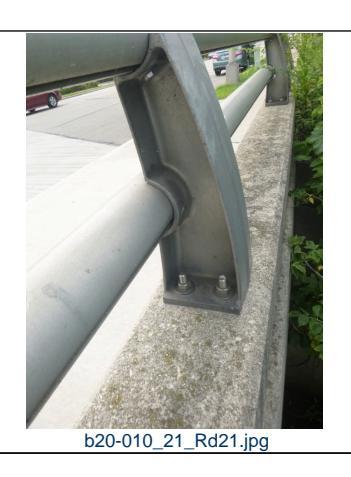
Routine Item 23

Missing nut and washer in decorative railing (NW corner)

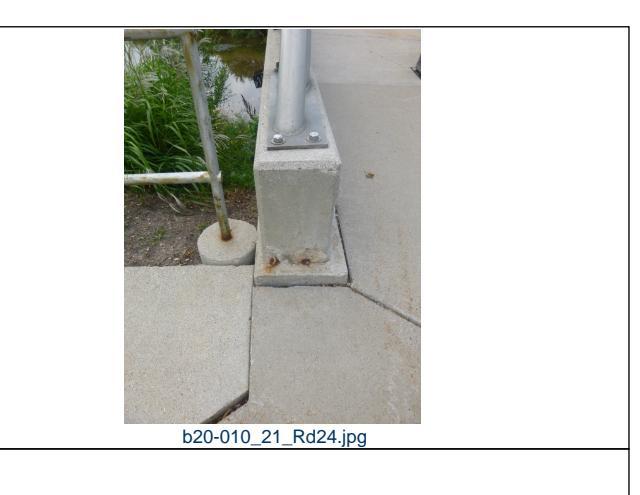
Routine Item 24

Minor spalls with exposed and corroded rebar at end of SE parapet, wingwall (CS2).

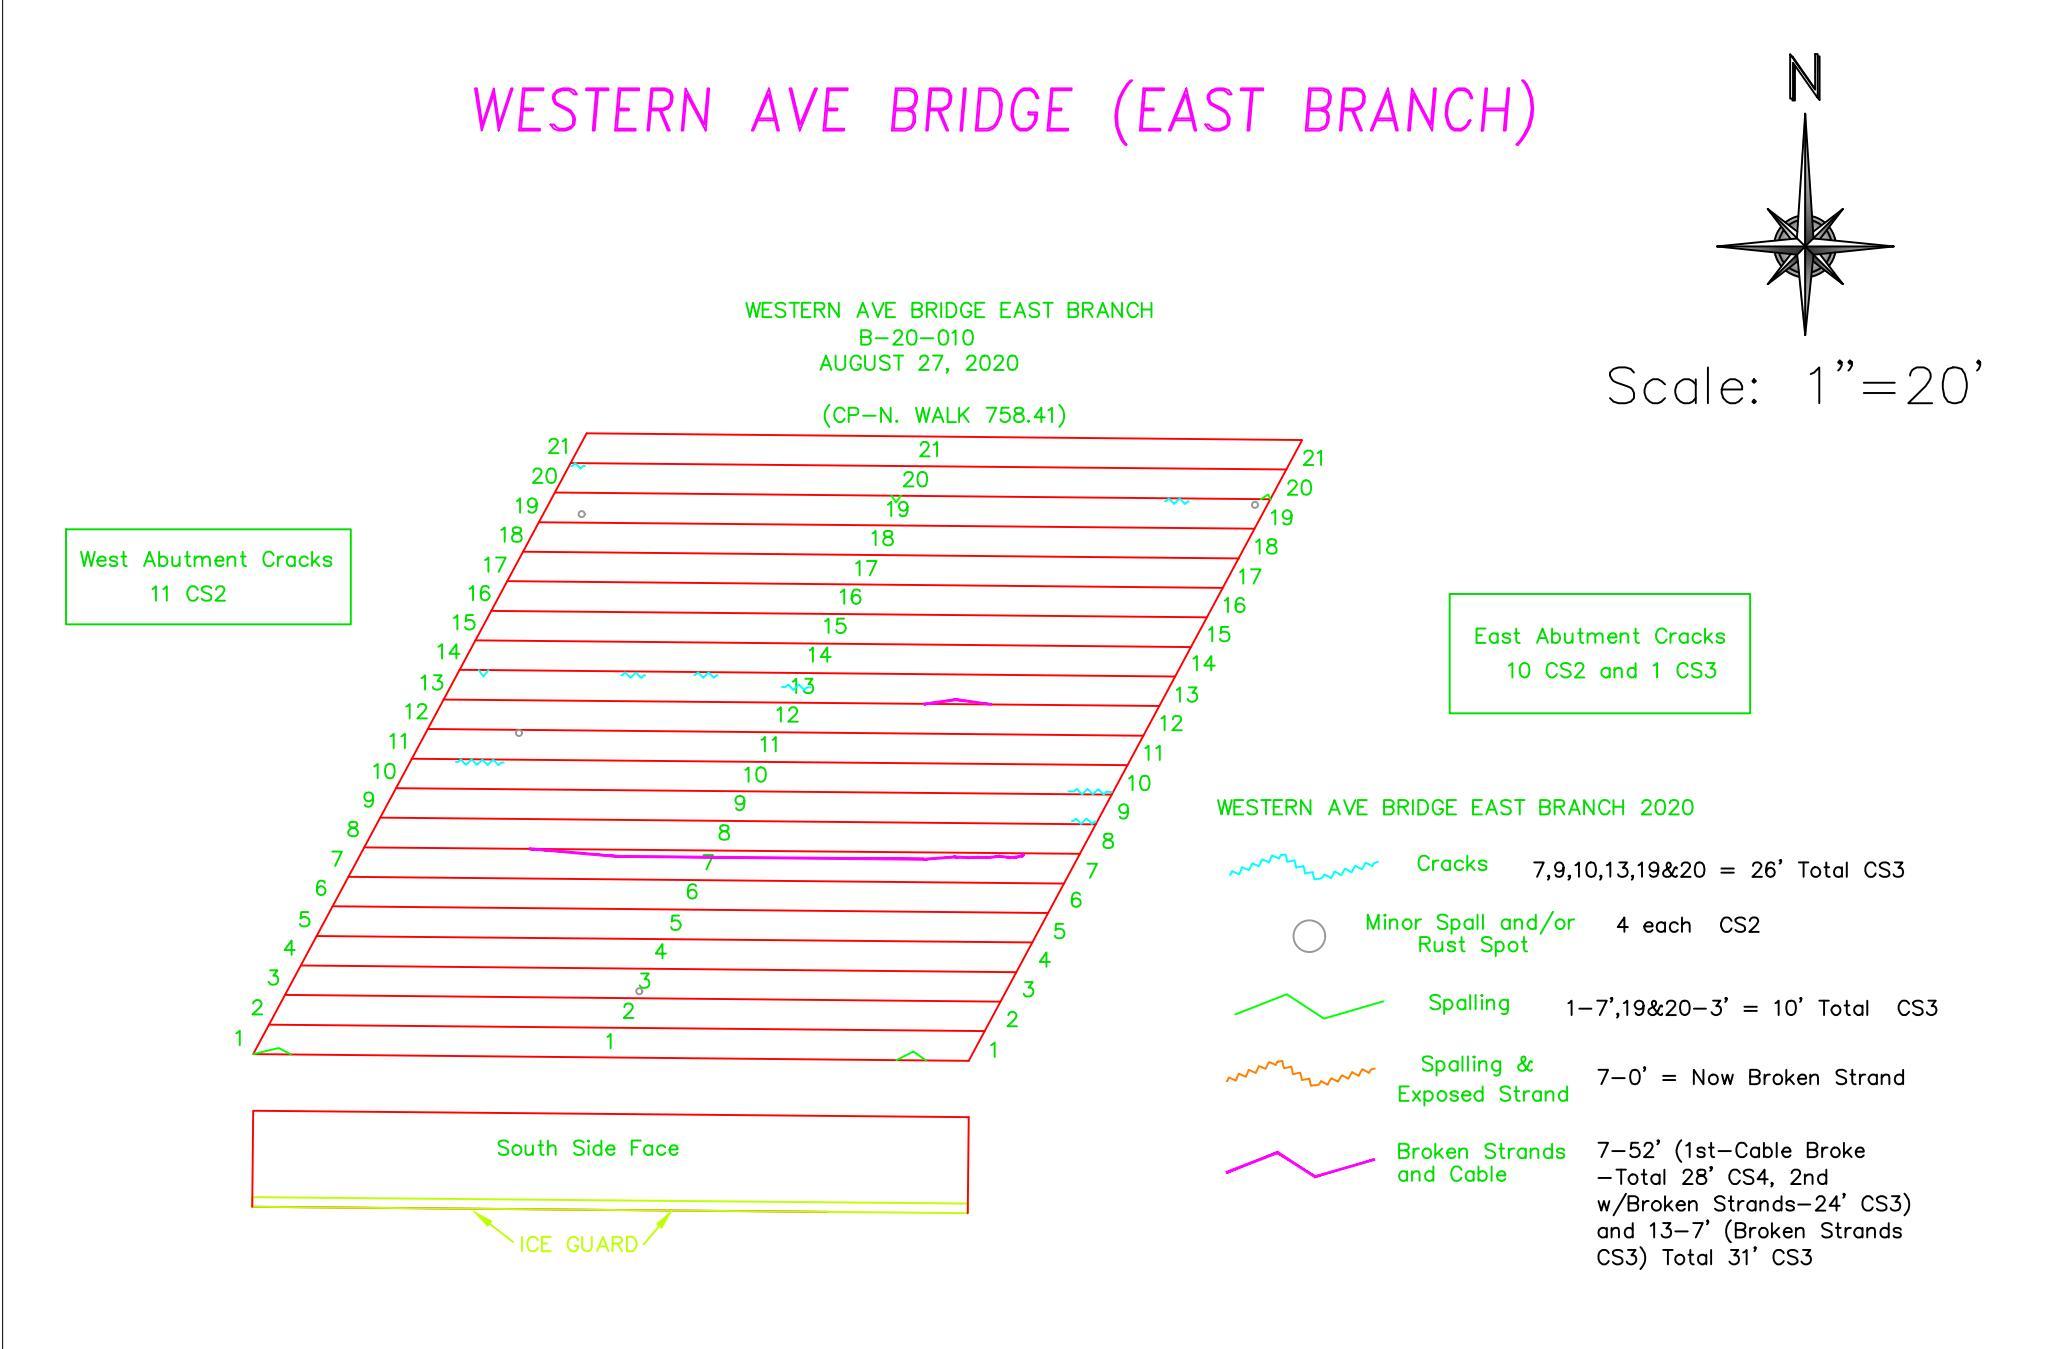
Ice angle rusted w/adj minor spalls Spalled bottom of box beams with exposed, rusted and broken prestressing strands. See attached pdf, pics and element breakdown

Culvert nine through NE portion of the east abutment. Minor	
corrosion. Flowline below water surface but doesn't appear to be	
corroded.	
	and the second s
	b20-010_21_Rd22.jpg
Linked Element(s):	
Cuivert End Treatment	
Routine Item 26	
Box Beam Survey of Defects	100.040.04. D-100 - 15 (include 1)
	b20-010_21_Ka23.pdf (Included)
